Operation Sidecar — **Gliders at Dial Post**

By Colin Rudling

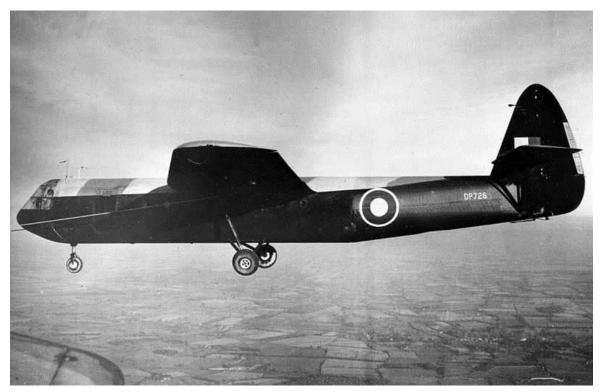
The gliders used in Operation Sidecar

The British built Airspeed Horsa glider was made completely of wood, had a wingspan of 88 feet and was 67 feet long. The load capacity was 7,750lbs.

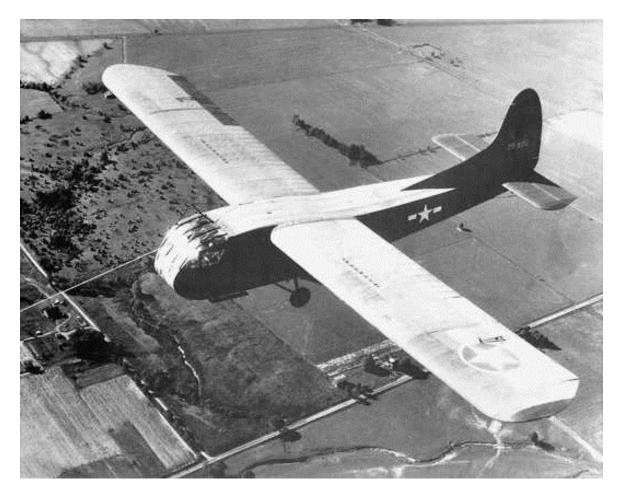
The American built CG-4A Waco was made of fabric covered wood and had a metal frame. Smaller than the Horsa, it had a wingspan of 84 feet and was 49 feet long. Its load capacity was around 3,700 lbs.

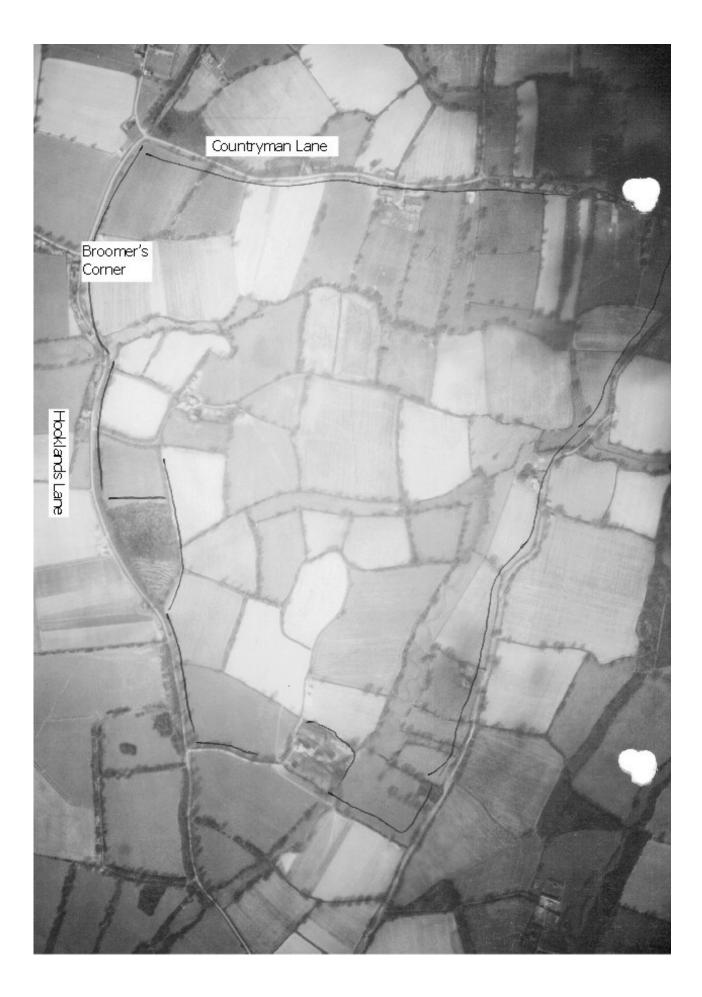
Aerial photograph taken prior to Operation Sidecar with target area marked

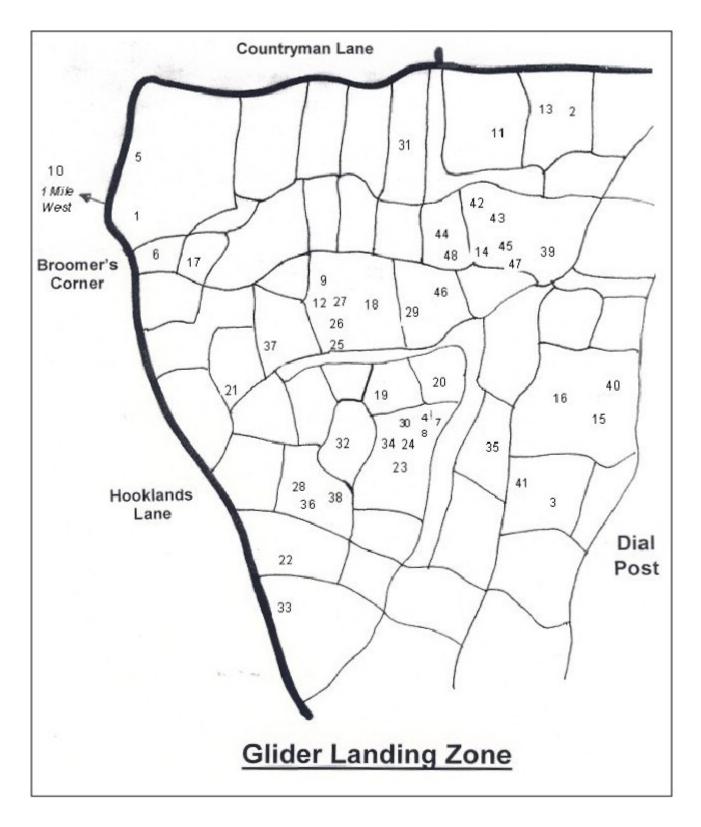
Plan showing location of landing of each Glider

The location of the landed gliders is shown on page 142.

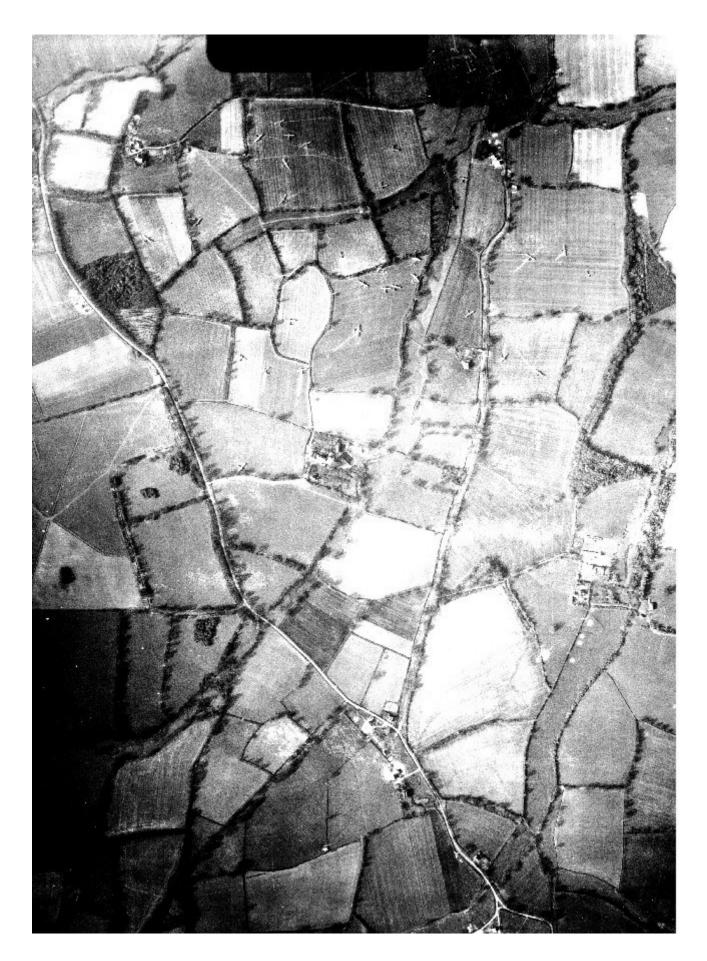
This aerial photograph was taken soon after the landings, and covers about two thirds of the landing area
